## It's All About the Response

On the afternoon of the 9<sup>th</sup> April 2019, the PLCS Technical Office received a call requesting urgent assistance in the repair of a low pressure 24" steel 90 degree welded segmented bend located in a very busy area.

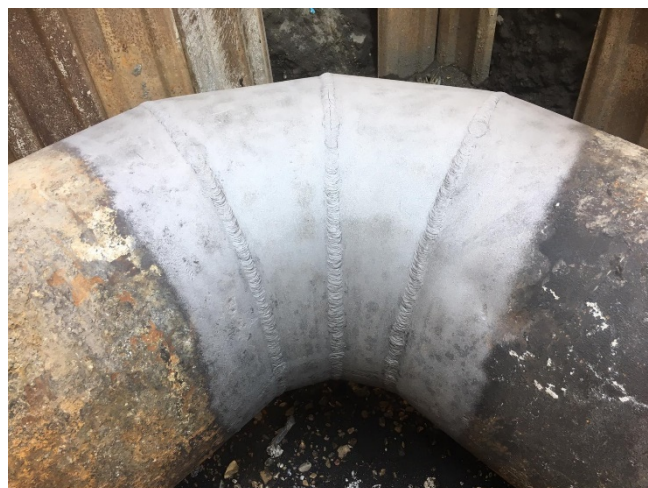
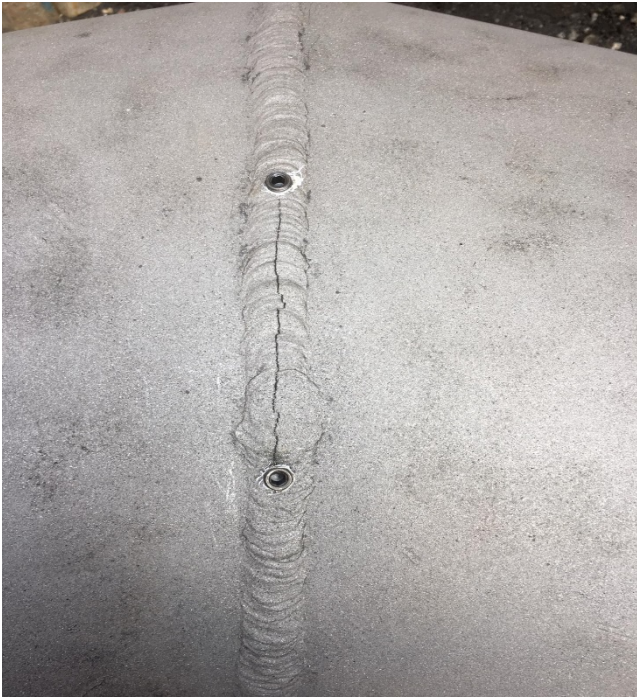
To make a full evaluation of the repair, a temporary wrapping, which had been placed around the pipe, was removed. The pipe was then cleaned and, the welded joints were grit blasted. On close inspection of the area around the escape it was revealed that there was a crack in the central welded joint.

To prevent further propagation, the ends of the crack were immediately drilled and plugged, and dimensions of the three joints were quickly sent back to PLCS by email so our team could begin work on the design of special fabricated kits.
