## It's All About the Response

On the afternoon of the 9<sup>th</sup> April 2019, the PLCS Technical Office received a call requesting urgent assistance in the repair of a low pressure 24" steel 90 degree welded segmented bend located in a very busy area.

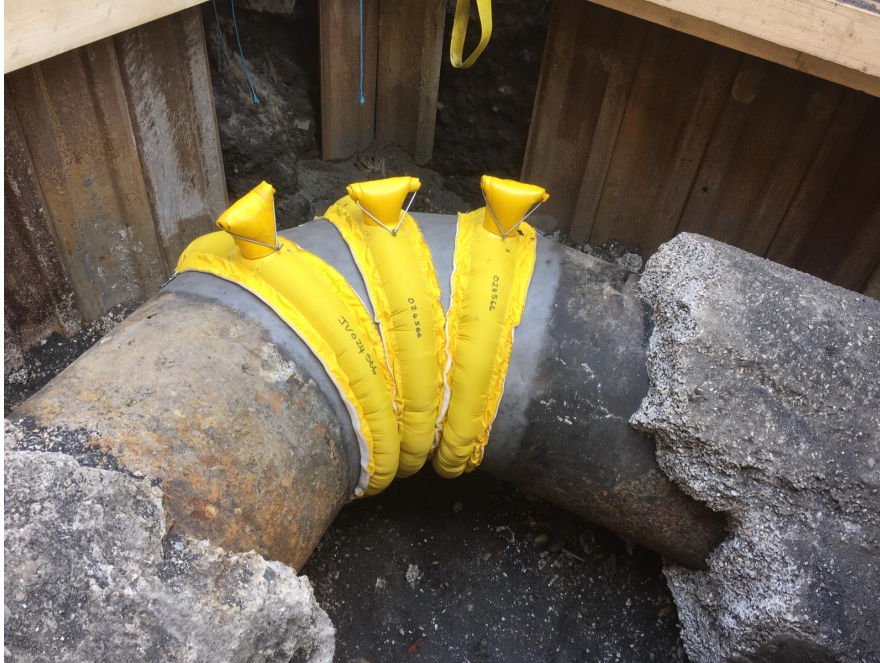
**The completed repair**

To prevent further propagation, the ends of the crack were immediately drilled and plugged, and dimensions of the three joints were quickly sent back to PLCS by email so our team could begin work on the design of special fabricated kits.

Our specialist engineering team returned to the site the following morning to complete the repairs, less than 24 hours after the initial call.
